# Restoration Aspirations Pt 5: Wiring

Electrics, or more precisely wiring looms, are the bane of old forestry machines. Simon Bowes discovers exactly why as he continues with his restoration project.

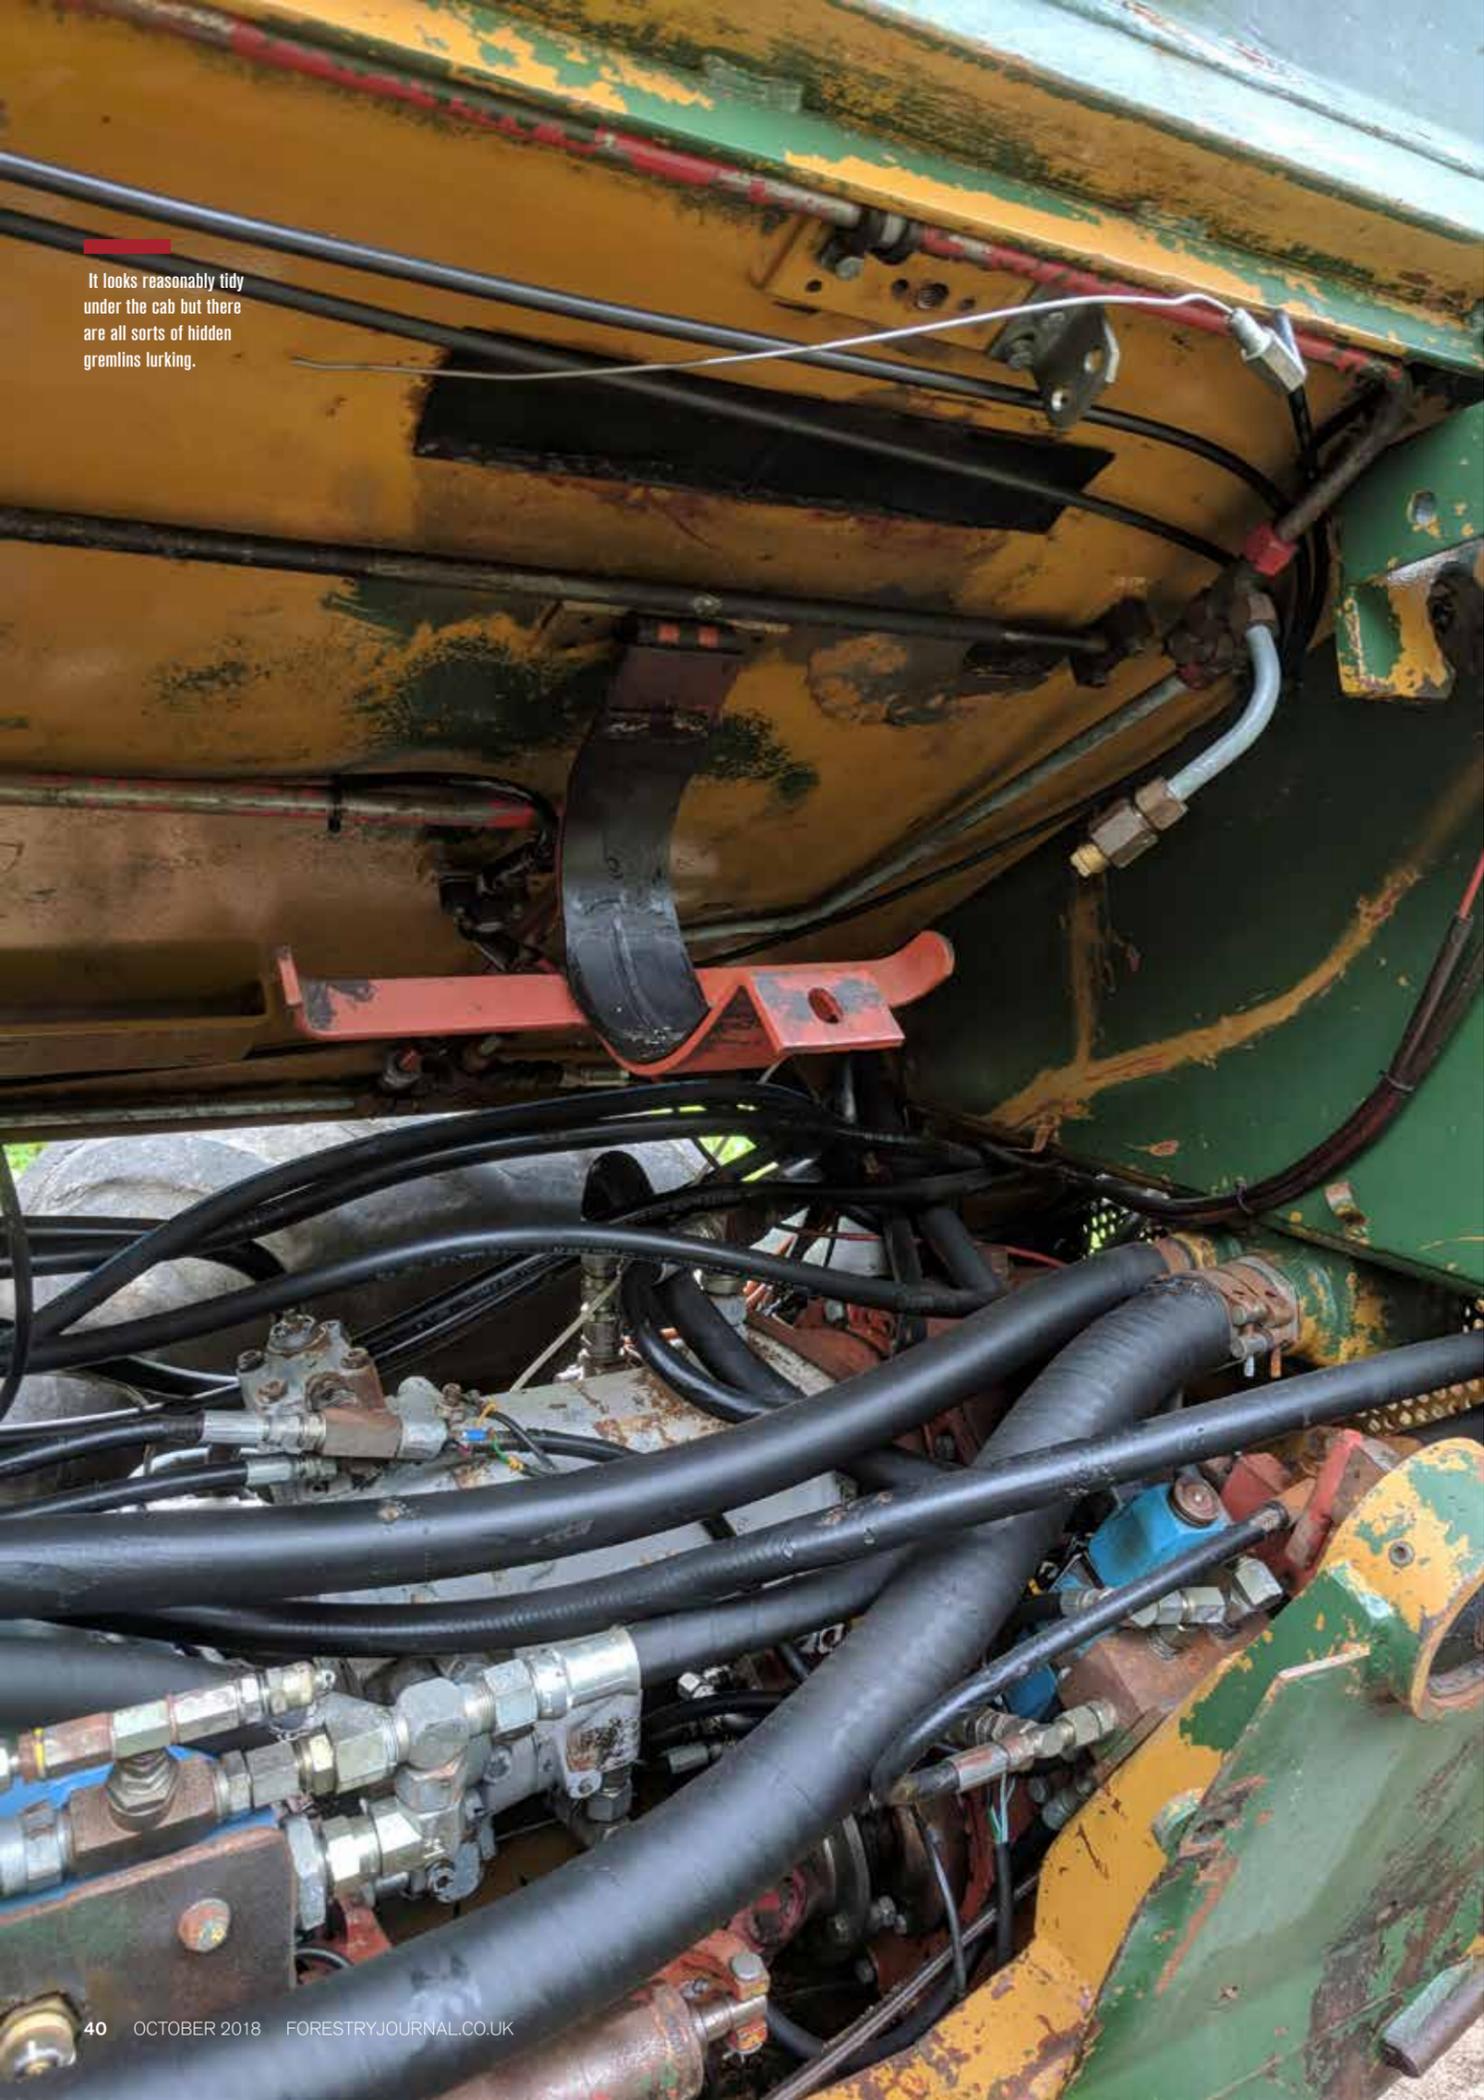
It looks reasonably tidy under the cab but there are all sorts of hidden gremlins lurking.

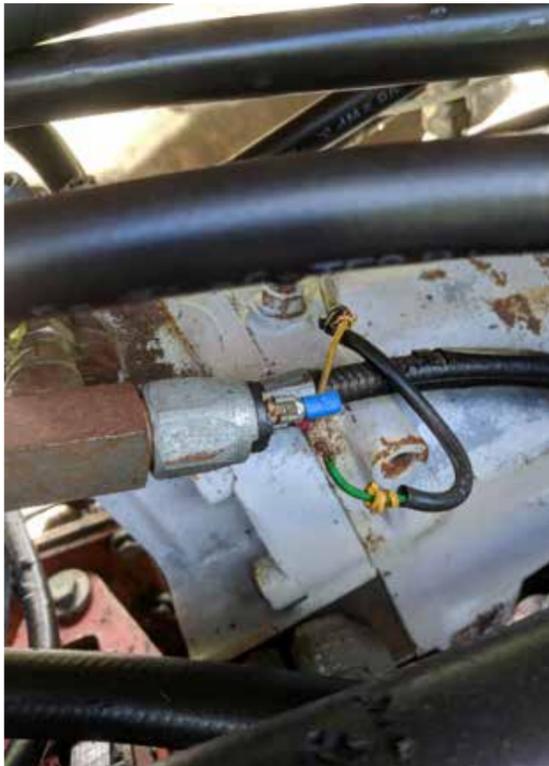
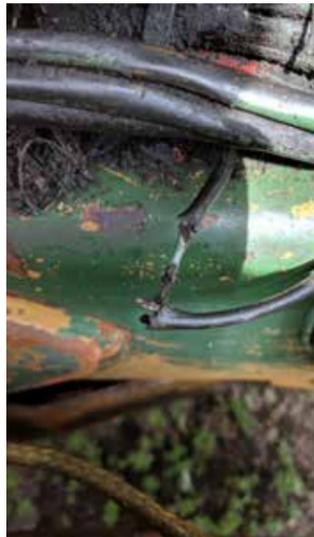
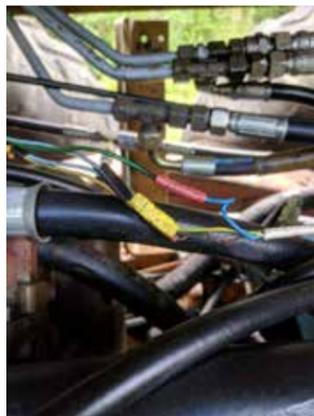
Just a few of the obvious wiring problems, the household cable (bottom right) with the bright yellow crimp is something of a novelty.

Once the essential wiring outside the cab had been tidied up, we turned to a whole bunch of wires that look like they've been melted at some point. The worst of this is the wiring for the trailer-type sockets that would have supplied the lighting boards for road lights when the machine was new. Removing the sockets and all the wiring made space in the wiring loom runs and got rid of more potential trouble spots. Stripping out the wiring for the fire-suppression system and the cab night heater freed up more space and tidied up a load of scruffy sub-loom. With black conduit fitted over the engine bay wiring it was starting to look tidier around the whole machine, but inside the cab needed a lot of attention, especially as we still have a lot of fuse holders with no fuses in. I can still just about remember what the Swedish script in the wiring and relay legend inside the cover means, but a quick look at Google Translate refreshed my memory. Some of it's easy; 'katastrofbroms' is simple to work out – catastrophe brake or emergency brake. What about 'akdrift' though? That's not so easy.

Hoovering the dust, broken glass and screws lost over the years allowed most of the panel to be seen and everything looked in reasonable order. I spent a couple of hours removing a load of redundant wires from the main power rail under the fuses. I'm not even sure what some of them had been used for in the past but once everything was tidied up I called our local mobile auto electrical guy in and let him loose for half a day. Ian went through everything; he made a new wiring harness for the cross-country steering, cutting out the length of hair dryer flex and replacing it with correct wiring fitted with proper plugs. He located and marked all the other extraneous wiring (the horn wiring was tucked in behind the batteries along with the wires for the headlights in the bonnet). He rewired the starter which had a jury-rigged trigger wire straight from the ignition switch instead of through the starter relay – effective, but not a permanent solution, and which would have caused problems in the future.

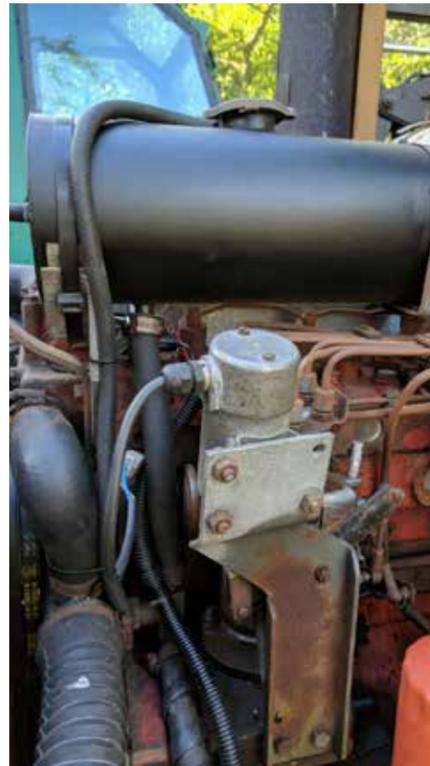
Stop solenoid with new wiring and miscellaneous diode removed now works faultlessly.

The stop solenoid is pretty simple in operation; it pulls with a supply and releases when the supply is removed so any major electrical fault will stop the engine. The solenoid on this one was held in the pulled position by a strong spring so the engine ran but didn't stop on the key. The fuse blew immediately it was replaced and the ignition was turned on. We removed the solenoid, stripped it down, replaced the dodgy cabling and wired it across the batteries where it worked perfectly. Refitting the cover and plugging it back in it again blew the fuse when the ignition was turned on. With a multimeter across the wiring we found both connections went straight to earth, and on careful inspection we discovered a diode that didn't seem necessary. Diodes are basically one-way valves that let power flow one way in a cable. They're generally used when a supply can't be allowed to flow back along a cable, usually when two functions are being triggered by the same circuit. The diode on the stop solenoid looked like it had been fitted to stop the live running straight to earth but it was the diode that was causing the short as one of its connecting wires was touching the solenoid's metal cap. Removing the diode cured the fault and refitting a more suitable spring in the correct position had the solenoid functioning properly with the

engine starting and stopping on the key.

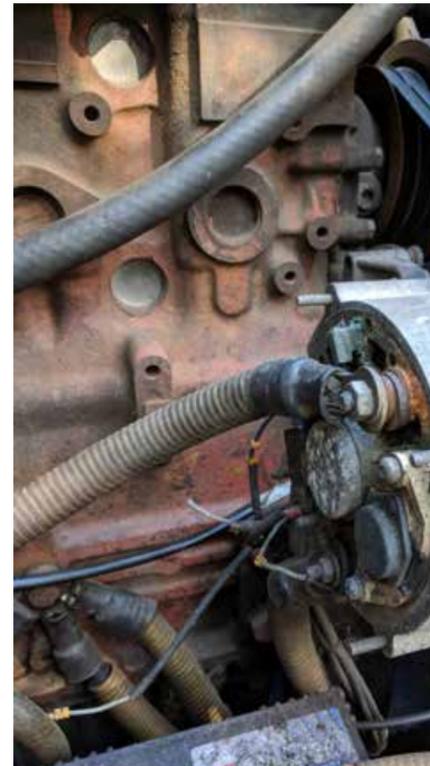
Alternator charges but it's a mystery how. Wiring will need attention before it can be trusted.
